Solving The Problem Of Hot Walled Ammonia Synthesis Converter

L. REDAELLI

Ammonia Casale S.A.

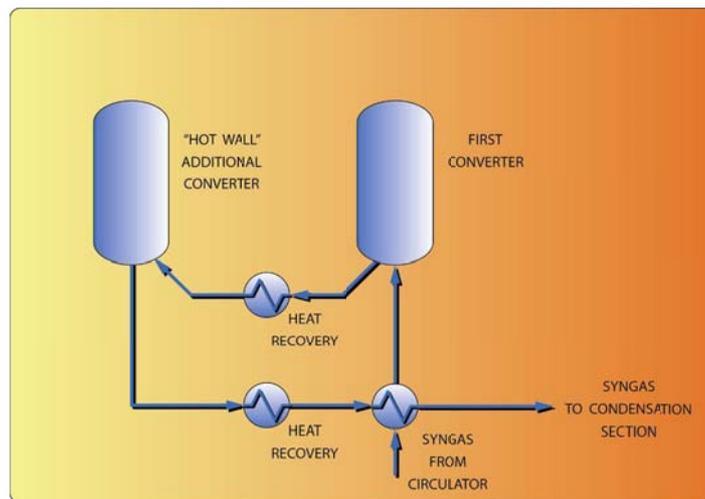
The typical additional converter scheme is shown in figure 1. This scheme is basically similar to the Brown multi-vessel scheme, but the first converter is usually a cold wall multi-bed converter and only the additional converter is a hot wall design. Typically the additional converter has been added at a later stage to increase Ammonia conversion or to reduce consumption.

In the additional converter, featured by partial opening, the hot gas coming from the first converter rich in ammonia is in direct contact with the pressure vessel walls.

Fig. 1: traditional scheme for additional hot wall converter

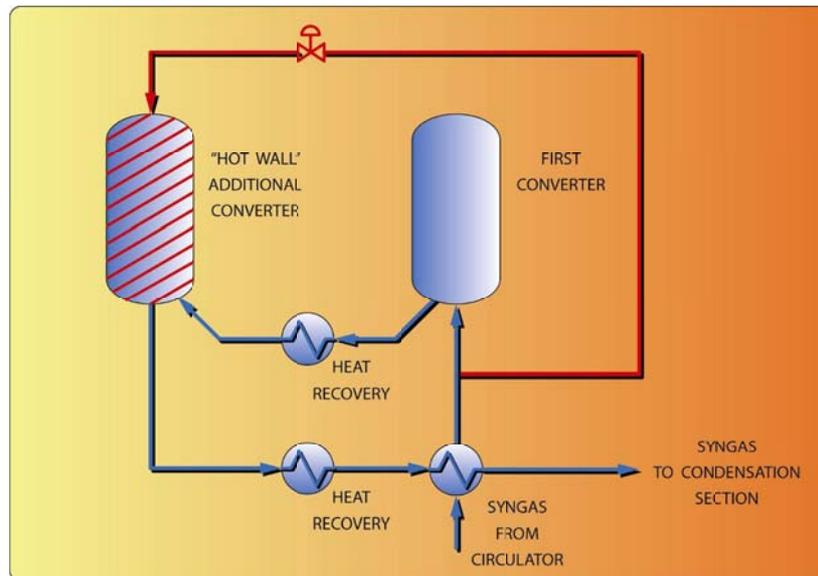
CASALE Modification, which is shown in figure 2, utilize a small percentage of the cold feed gas going to the first converter as a flush gas for the additional converter vessel. After flushing this gas mixes with the hot gas coming from the first converter before entering the catalytic bed contained in a new cartridge built inside the additional converter.

Fig. 2: Modifications to change from hot wall design to cold wall design the additional converter

The cold flushing gas is therefore taken from the hot gas-gas outlet, bypassing the first reactor and acting as a quench for the additional converter.

The internal flushing is made possible thanks to the installation of a new cartridge and new internals. Since the vessel often is not a full open one, the cartridge and the internals should be mounted and welded directly on field, inserting them through the available manway/opening.

In addition to the new internals the intervention includes a new top cover with an additional nozzle for flushing gas inlet for the manway/opening and a new bypass line to feed the flushing gas to the additional converter, equipped with a regulating valve.

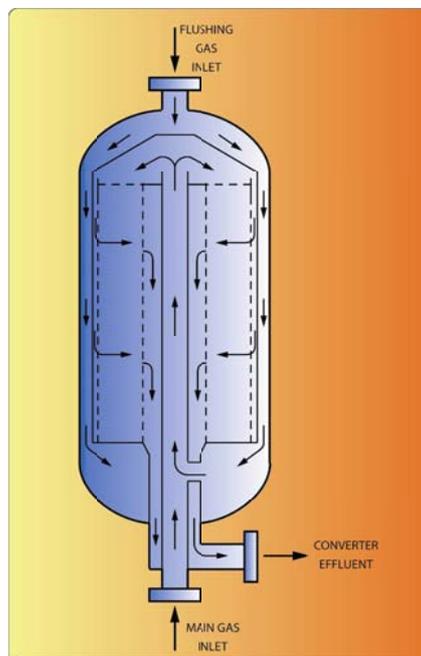
Fig. 3: Flow pattern in the modified converter

The flushing gas enters the converter from the new top cover nozzle and flushes the internal wall of the vessel by flowing downwards along the cylindrical annulus between the cartridge and the pressure shell. In this way, the pressure vessel is protected against high temperature and maintained at the same temperature of the feed gas. The cartridge is thermally insulated. The main gas enters from the existing inlet nozzle and mixes with the flushing gas on the bottom of the converter inside the new cartridge. Then the mixed gas goes up through the internal pipe and enters the axial-radial catalytic bed. The reacted gas is collected and goes out the converter through the existing outlet nozzle.

- Ø The high efficiency of CASALE cartridge axial-radial design allows only a little reduction in converter performances if compared with the "HOT WALL" design.
- Ø CASALE cartridge allows loading more than the 80% of the catalyst volume loaded before the intervention.
- Ø The flow path inside the modified additional converter is shown in figure 3.

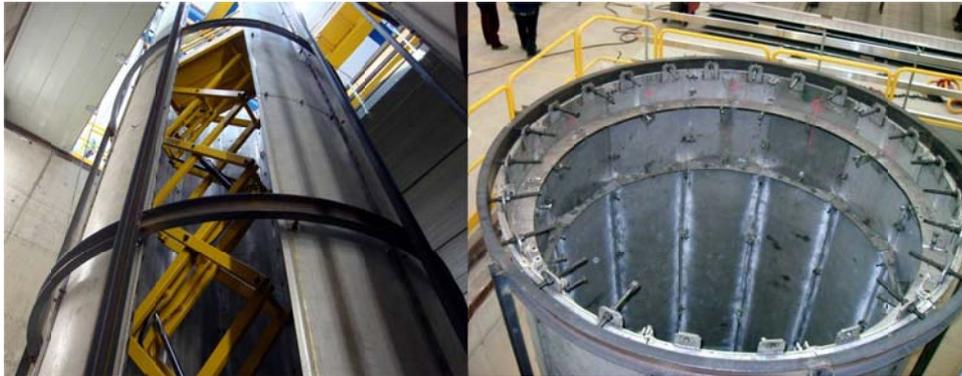
Anyway its experience in revamping works, where delivery and installation time is essential, helped Casale to meet such a close delivery. Some phase of the preassembly is shown in picture 1

Picture 1: Converter Internals assembly in workshop

Trial assembly in workshop are performed to assure final dimension and detect any possible problem.

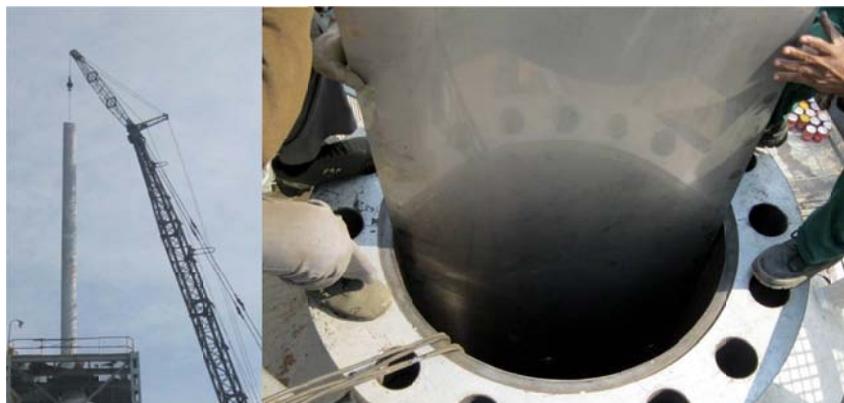
Some picture of the modules insertion and installation is shown in picture 2 and 3.

Picture 2: Converter modules insertion in the vessel

For this reason a modular design was selected. Each module, which could be inserted through the opening, already incorporate the cartridge wall, its insulation and the catalytic bed outer wall. Each module is a full height independent sector of the cartridge, therefore once the new bottom is assembled the modules can be simply installed side by side to form the cartridge and the outer catalytic bed. After the modules are placed, the inner collector, which usually can be inserted in a single piece, and the top cover in sector can be installed.

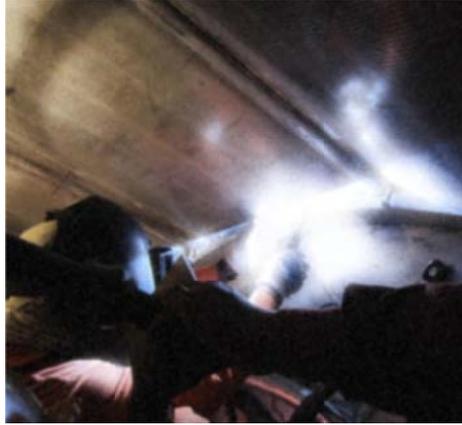
Picture 3: Converter modules installation inside the vessel
